National Electric Power Regulatory Authority Islamic Republic of Pakistan

Electrician Electrocution

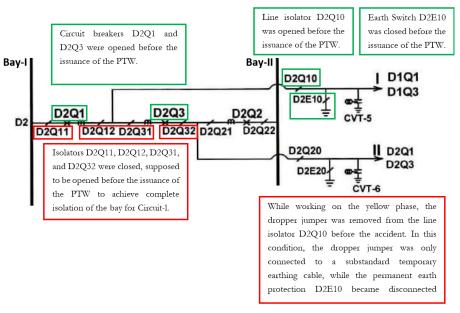
After the issuance of a Permit to Work (PTW), involving the opening of circuit breakers D2Q1 and D2Q3, the line isolator D2Q10, and the closure of the Earth Switch D2E10 of 220kV Circuit-I, the grid maintenance team began the project work. The 220kV Circuit-II remained energized while the work was in progress.

Figure-1: Single Line Diagram

- 5. **Incorrect PTW Issuance:** The PTW was issued with an incorrect isolation scheme, missing the opening of isolators D2Q11, D2Q12, D2Q31, and D2Q32 necessary for complete isolation.
