NEPRA Incident Alert # 2024-01/ June 06, 2024

Lineman Fall Accident

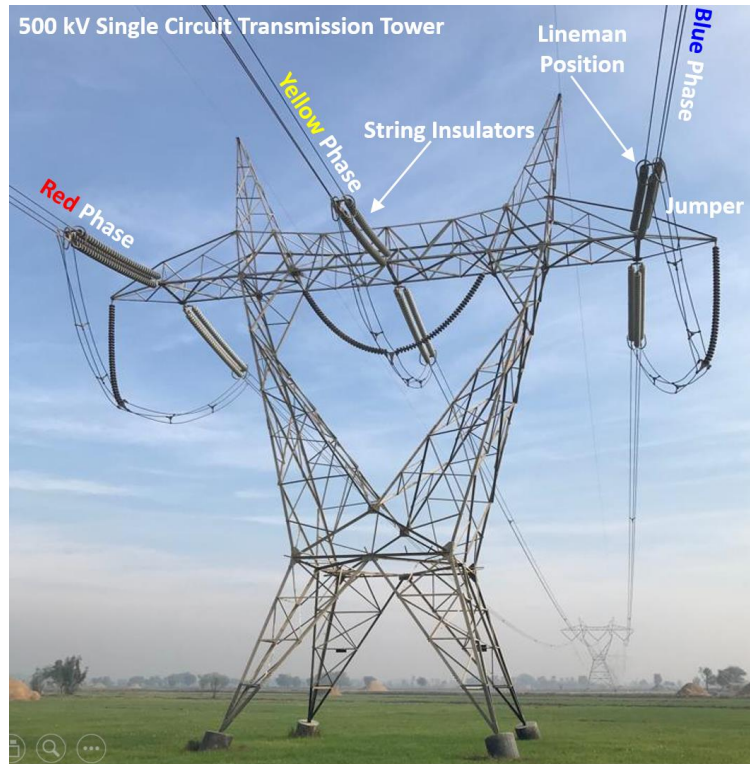
Figure-1: Transmission Tower

On February 28, 2023, at approximately 10:15 Hours, the 500kV transmission line tripped. Field patrol revealed partial collapse of towers. Rehabilitation work commenced and was successfully complete. On March 15, 2023, a team supervised by an Assistant Engineer was assigned to re-jumper the transmission line at a tower under a Permit to Work (PTW). The weather was cloudy and fair according to weather data.

A lineman equipped with a single lanyard body belt (positioning belt) completed the re-jumpering of the Red and Yellow phases and then moved to the Blue phase to perform re-jumpering. While adjusting his position and maneuvering around the string insulator through the corona plate, he detached the single lanyard from the anchorage point. As he stepped on the string insulator, he lost his balance, slipped, and fell from a height of approximately 14 meters (45 feet) to the ground. He was transported to the nearest Health Care Centre, where he was pronounced dead upon arrival.

- 1. Discard Substandard Body Belts:** Remove all substandard body belts from all sites, as the use of a lineman body belt (positioning belt) for fall arrest or a full body safety harness with a single lanyard is strictly prohibited.

- 3. Equip with Proper Safety Gear:** Provide full-body safety harness with front work positioning belt (positioning lanyard) along with double lanyard for 100% tie at all sites for climbers while working on height more than 6 feet/1.8 meter above the ground or impact level, including when climbing poles, towers and structures or using mobile elevated aerial platform, man-baskets, man-lift or bucket mounted vehicles. Full-body harness with front work positioning belt allow employees to be supported on an elevated vertical surface such as a wall or pole and to work with both hands free.

- 5. Anchor Safety Harness Properly:** Ensure the safety harness lanyard is anchored to a rigged anchorage point at height, maintain a fall clearance safety factor of two (02) feet from the impact level or ground level.
